**Atari Technical Bulletin**  
**Number: TT30-0003**  
**Date: March 24, 1992**  
**Page 1 of 2**

Product(s) Affected: TT030  
Model: All  
Type of ATB: As Needed  
ECO #: N/A

To correct improper jumper setting causing coprocessor to run at 16MHz instead of 32MHz.

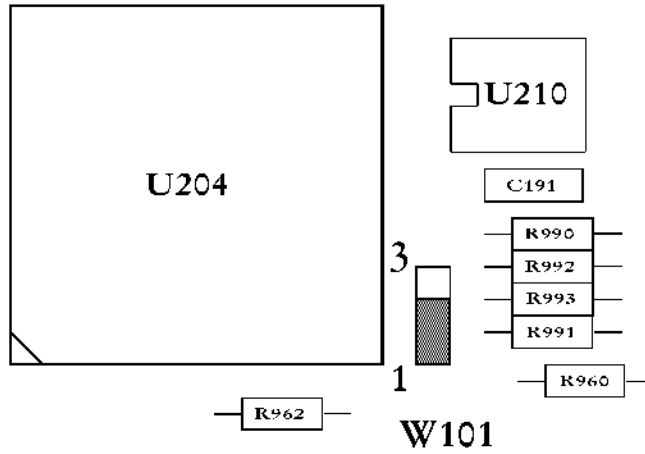
For FAB C301763-001 REV D and C302406-001 REV A see Figure 1 on page 2.

Be sure the jumper is parked across pins 1 and 2.
3. Re-assemble unit.

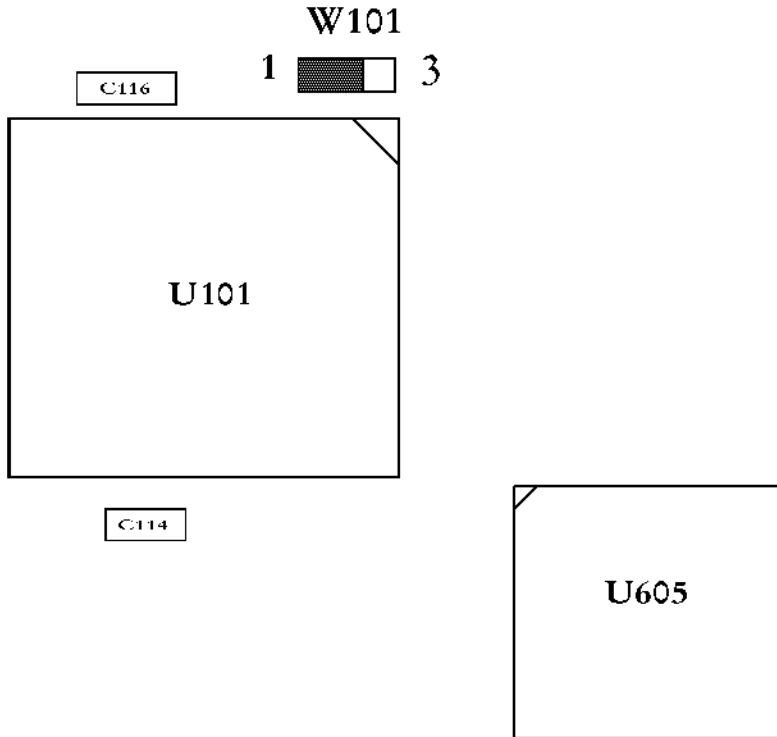
For FAB C301763-001 REV B1 see Figure 2 on page 2.
