Atari Technical Bulletin
Number: TT30-0004
Date: March 27, 1992
Page 1 of 3

Product(s) Affected: TT030
Model: All
Type of ATB: As Needed
ECO #: 1434

To correct boot up problems on C301763-001 REV D FAB boards after ATB TT30-0002 or ECO 1425 was applied.

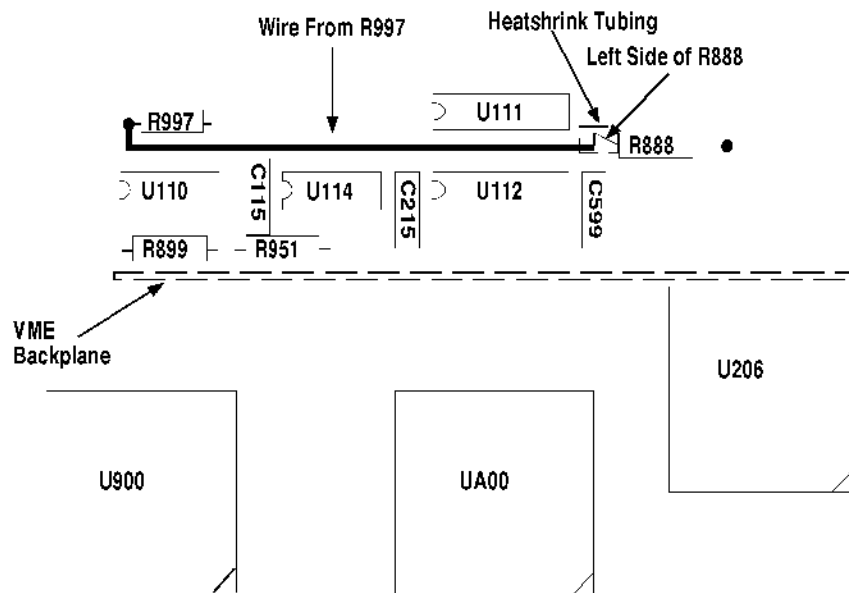
Figure 1

After installing the fix described in ATB TT30-0002 or ECO 1425 several TT030 systems using the C301763-001 REV D FAB main board exhibited problems booting when a TT RAM board is installed. The following procedure will correct those problems. The problem only pertains to the C301763-001 REV D FAB.

During boot-up the system will fail with X's when TT RAM test is performed or bomb on Boot-up if TT RAM is installed.

3. If ECO 1425 or ATB TT30-0002 is not installed, skip to step 4. If the first oscillator modification is installed, ECO 1425 or ATB TT30-0002, remove the wire from the left side of R888 and R997. See Figure 1.
4. Lift pins 3 and 17 of U210 so the pins are clear of the pads on the main PCB. See Figure 2.
5. Connect a wire from the right side of R997 to U210 pin 17. See Figure 2.
6. Connect a wire from U210 pin 3 to the left side of R888. See Figure 2.
7. Insulate the connection at R888 with Heatshrink Tubing to guard against any possible shorts. See Figure 2.
8. Re-assemble the unit.
