**Atari Technical Bulletin**  
**Number: TT30-0006**  
**Date: May 8, 1992**  
**Page 1 of 3**

Product(s) Affected: TT030  
Model: All  
Type of ATB: As Needed  
ECO #: 1451

To correct boot up problems on C302406-001 REV A FAB boards after ATB TT30-0002 or ECO 1425 was applied.

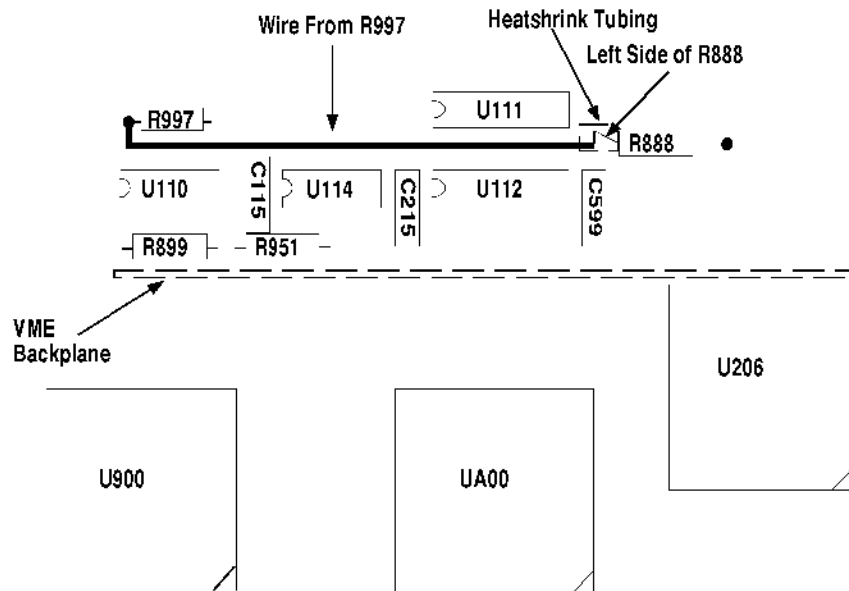
Figure 1

During boot-up the system will fail with X's when TT RAM test is performed or bomb on Boot-up if TT RAM is installed, and the TT RAM board is set for burst mode. (Jumper W105 installed between pins 2 and 3 on the TT RAM board).

3. If ECO 1425 or ATB TT30-0002 is not installed, skip to step 4. If the first oscillator modification is installed, ECO 1425 or ATB TT30-0002, remove the wire from the left side of R888 and R997. See Figure 1.
4. Lift pins 3 and 17 of U210 so the pins are clear of the pads on the main PCB. See Figure 2.
5. Connect a wire from the right side of R997 to U210 pin 17. See Figure 2.
6. Connect a wire from U210 pin 3 to the left side of R888. See Figure 2.
7. Insulate the connection at R888 with Heatshrink Tubing to guard against any possible shorts. See Figure 2.
8. Re-assemble the unit.
